Contract Report

September 1991

**SOIL BIOENGINEERING
CORPORATION
MARIETTA, GA**

**SOIL BIOENGINEERING
MAJOR GULLY WASHOUT REPAIR,
SILVERHILL AIRFIELD,
BALDWIN COUNTY, ALABAMA**

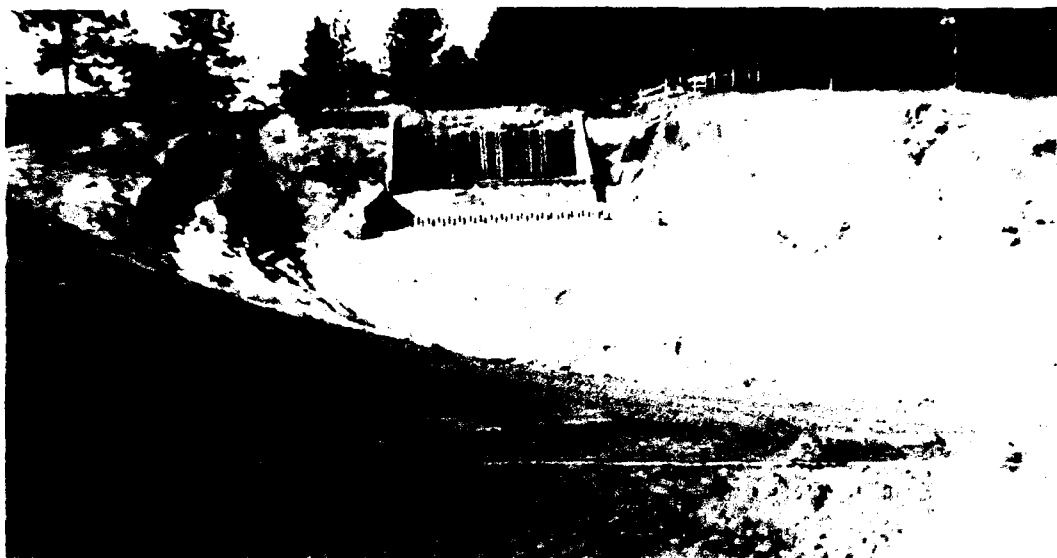
Photo 2. The existing drop structure area during the early stages of construction
